Reliability Laboratory

TEST REPORT

Report No.: HC20092/2008

1. JetNet PoE Switch
2. JetBox 8100 Industrial Communication Computer
3. JetBox 9300 Industrial Communication Computer

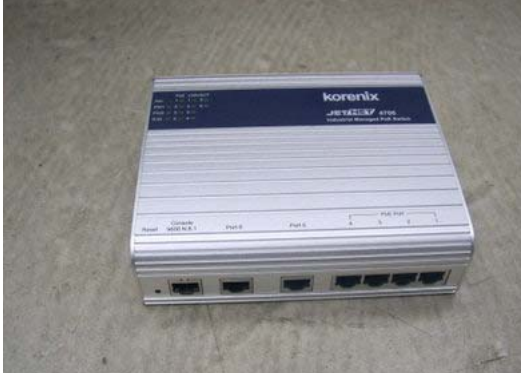
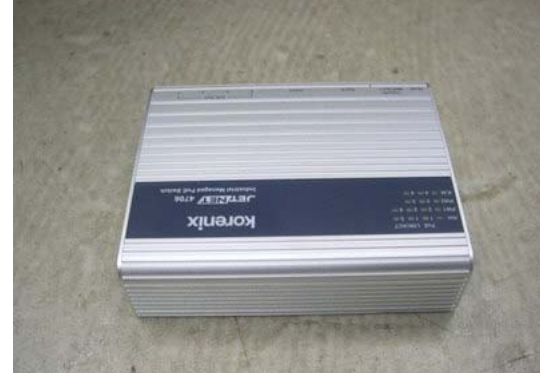
<p>1. Appearance of specimen (JetNet 4706 Industrial 6-port managed PoE Switch)</p>	<p>2. Appearance of specimen (JetNet 4706 Industrial 6-port managed PoE Switch)</p>

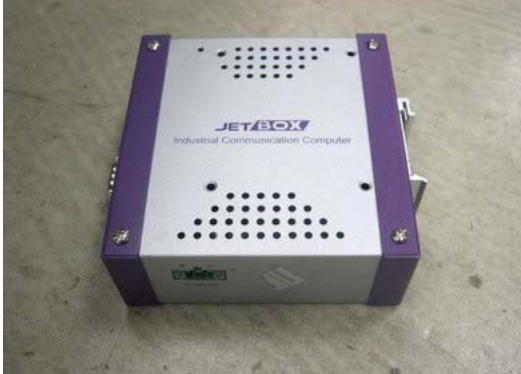
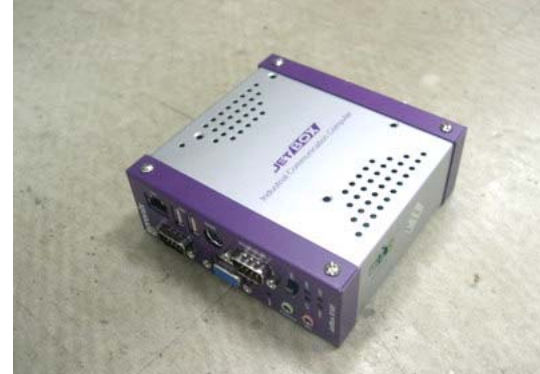
<p>3. Appearance of specimen (JetBox 8100)</p>	<p>4. Appearance of specimen (JetBox 8100)</p>

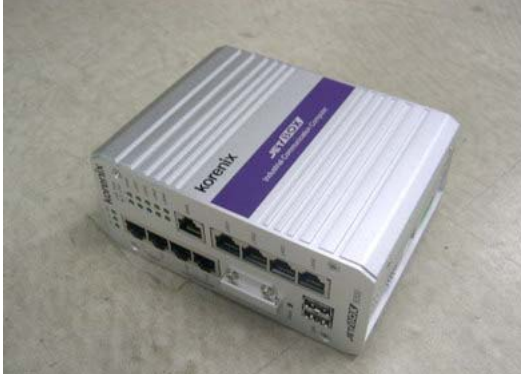
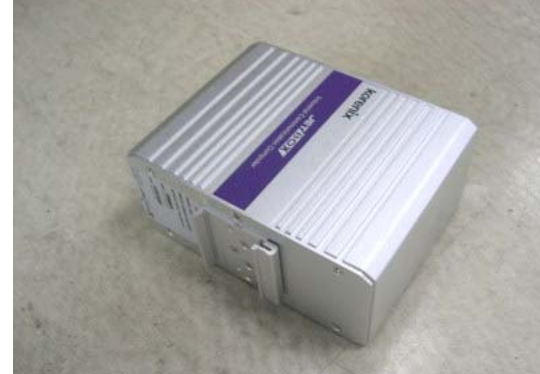
<p>5. Appearance of specimen (JetBox 9300)</p>	<p>6. Appearance of specimen (JetBox 9300)</p>

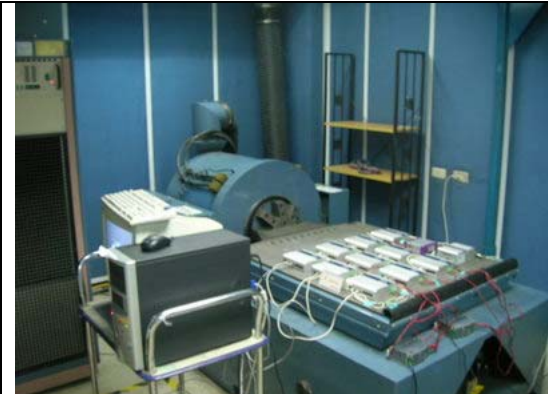
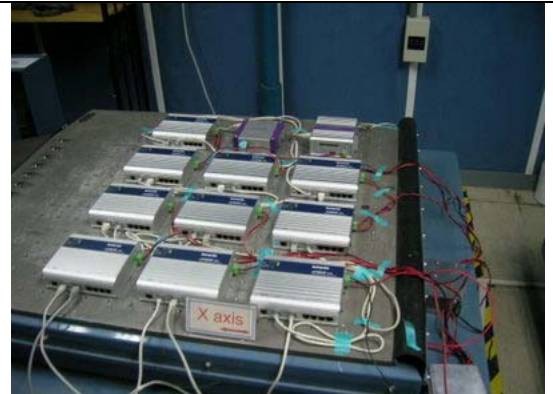
7. Operating Vibration Test --X axis

8. Operating Vibration Test --X axis

Direction: X, Y, Z axes (see photo 7~12)

Longitudinal – X axis			
Frequency (Hz)	Left Slope (dB/Oct.)	PSD (m/s ²) ² /Hz	Right Slope (dB/Oct.)
5	-	0.015163	0
20	0	0.015163	-6
150	-6	0.000273	-
⇒ equivalent to 0.7(m/s ²) rms

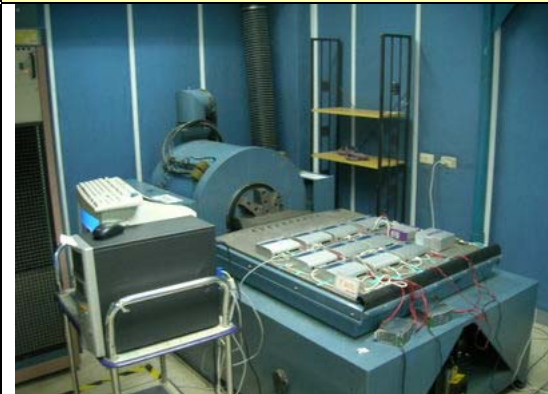
9. Operating Vibration Test --Y axis

10. Operating Vibration Test --Y axis

Transverse – Y axis			
Frequency (Hz)	Left Slope (dB/Oct.)	PSD (m/s ²) ² /Hz	Right Slope (dB/Oct.)
5	-	0.006266	0
20	0	0.006266	-6
150	-6	0.000113	-
⇒ equivalent to 0.45 (m/s ²) rms

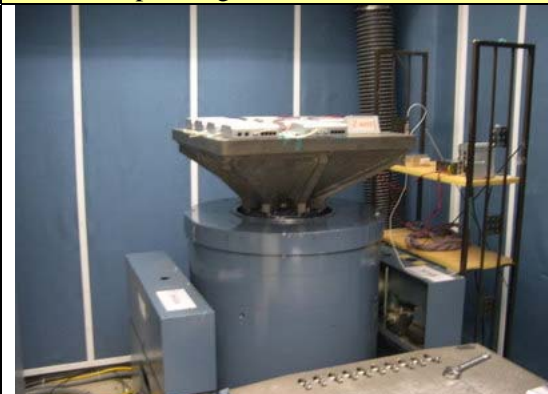
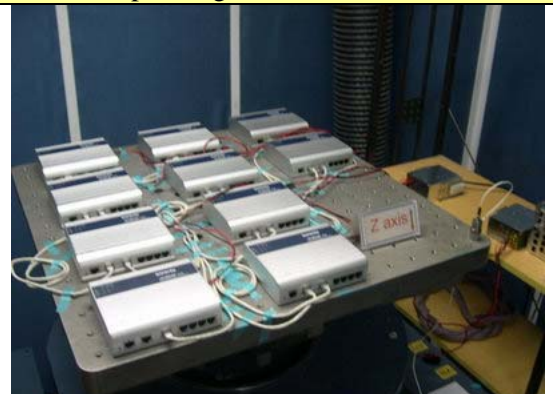
11. Operating Vibration Test --Z axis

12. Operating Vibration Test --Z axis

Vertical – Z axis			
Frequency (Hz)	Left Slope (dB/Oct.)	PSD (m/s ²) ² /Hz	Right Slope (dB/Oct.)
5	-	0.030945	0
20	0	0.030945	-6
150	-6	0.000558	-
⇒ equivalent to 1 (m/s ²) rms

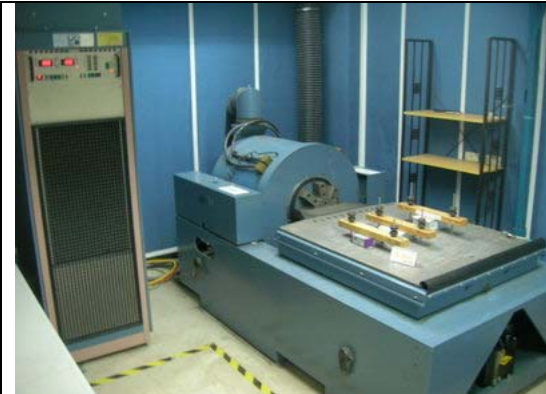
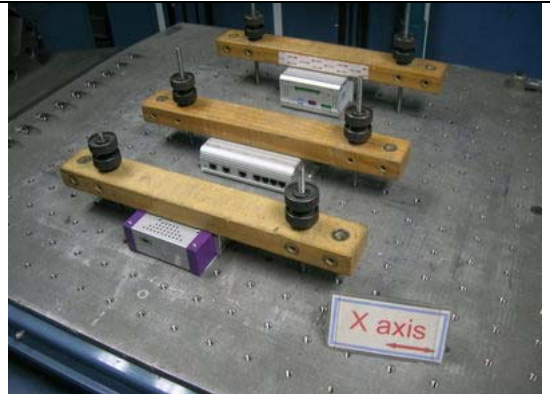
13. Non-Operating Vibration Test --X axis

14. Non-Operating Vibration Test --X axis

Direction: X, Y, Z axes (see photo 13~18)

Longitudinal – X axis			
Frequency (Hz)	Left Slope (dB/Oct.)	PSD (m/s ²) ² /Hz	Right Slope (dB/Oct.)
5	-	0.936079	0
20	0	0.936079	-6
150	-6	0.016873	-
⇒ equivalent to 5.5 (m/s ²) rms

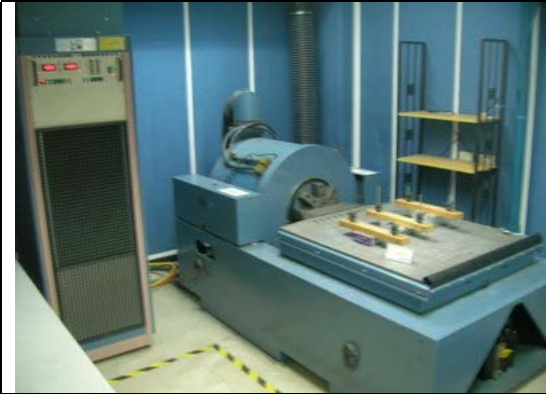
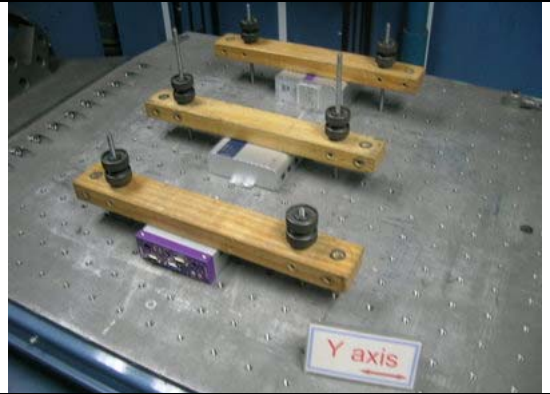
15. Non-Operating Vibration Test --Y axis

16. Non-Operating Vibration Test --Y axis

Transverse – Y axis			
Frequency (Hz)	Left Slope (dB/Oct.)	PSD (m/s ²) ² /Hz	Right Slope (dB/Oct.)
5	-	0.379073	0
20	0	0.379073	-6
150	-6	0.006833	-
⇒ equivalent to 3.5 (m/s ²) rms

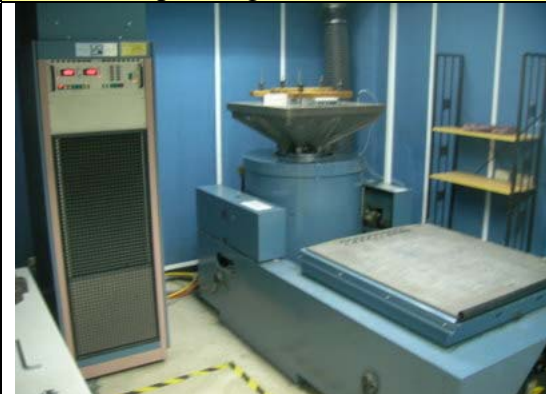
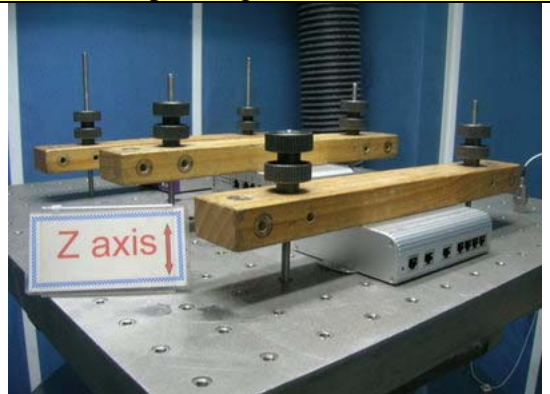
17. Non-Operating Vibration Test --Z axis

18. Non-Operating Vibration Test --Z axis

Vertical – Z axis			
Frequency (Hz)	Left Slope (dB/Oct.)	PSD (m/s ²) ² /Hz	Right Slope (dB/Oct.)
5	-	1.931260	0
20	0	1.931260	-6
150	-6	0.034810	-
⇒ equivalent to 7.9 (m/s ²) rms

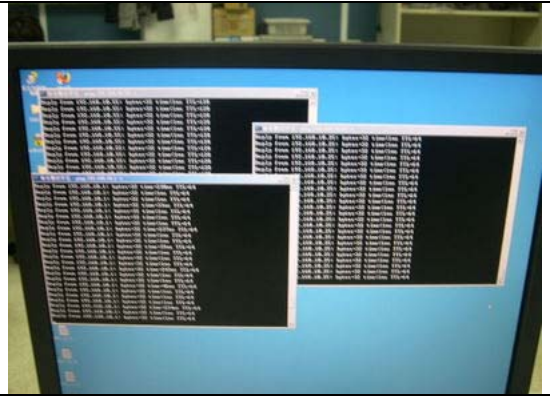
19. Functional check

20. Functional check

- Examine the appearance of specimen(s) by visual check and perform functional check after this test.
- Functional check: Connect the specimen with PC via RJ-45 port and examine the Network Connecting Function of specimen could be work normally or not.
