## TEST REPORT

Report No.: HC20130/2008

Product Description: Industrial Communication Computer

Style/ Item No.: JetBox9300/ No.1

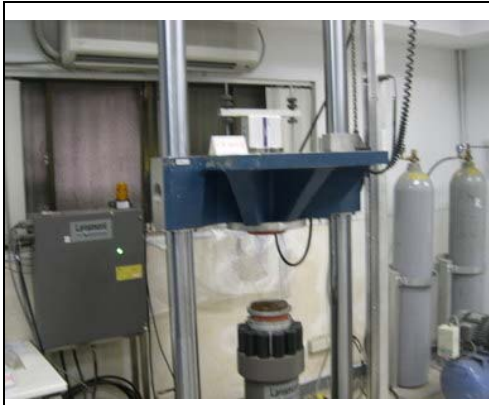
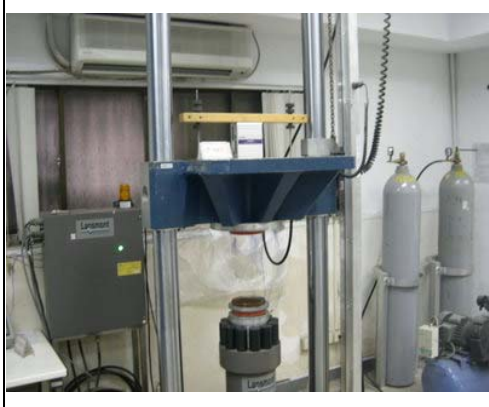
<p>4.Mechanical Shock test: <math>\pm X</math> axis</p>	<p>5.Mechanical Shock test: +X axis</p>	<p>6.Mechanical Shock test: -X axis</p>

Shock direction: 6 faces (±X, ±Y, ±Z axes. See photo 4 ~ 12)

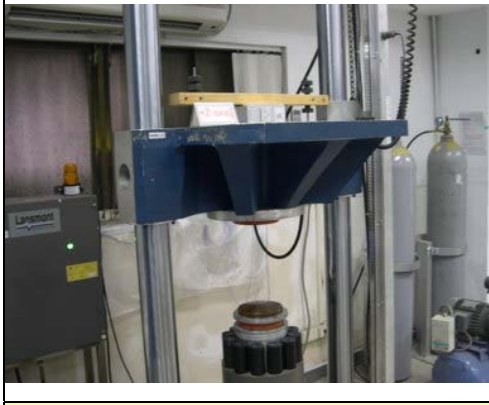
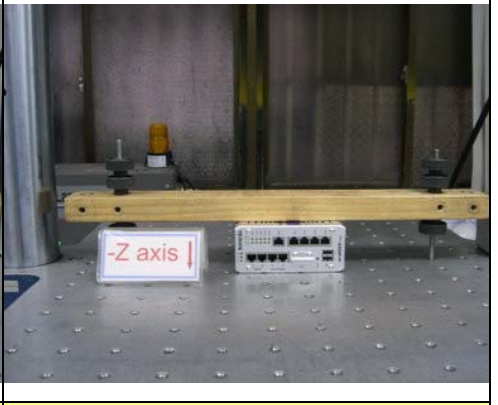
<p>7.Mechanical Shock test: <math>\pm Y</math> axis</p>	<p>8.Mechanical Shock test: +Y axis</p>	<p>9.Mechanical Shock test: -Y axis</p>

<p>10.Mechanical Shock test: <math>\pm Z</math> axis</p>	<p>11.Mechanical Shock test: +Z axis</p>	<p>12.Mechanical Shock test: -Z axis</p>
