TEST REPORT

Report No.: HC20131/2008
Page: 1 of 5
Date: March 3, 2008

Product Description: Industrial Communication Computer
Style/ Item No.: JetBox8210/ No.1
Quantity: Total 1 set
Testing Period: Feb. 19, 2008

Test Required: (According to client's test specification, please see following sheets in detail.)
1. Mechanical Shock Test

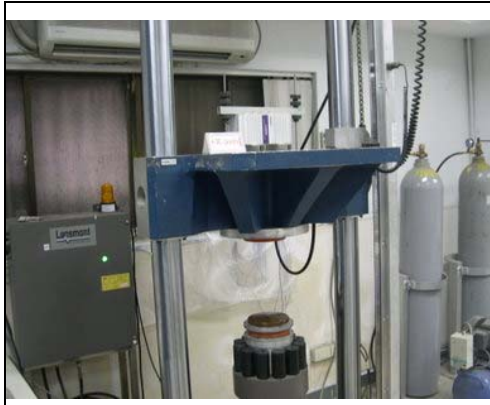
<p>4.Mechanical Shock test: $\pm X$ axis</p>	<p>5.Mechanical Shock test: +X axis</p>	<p>6.Mechanical Shock test: -X axis</p>

Shock direction: 6 faces (±X, ±Y, ±Z axes. See photo 4 ~ 12)

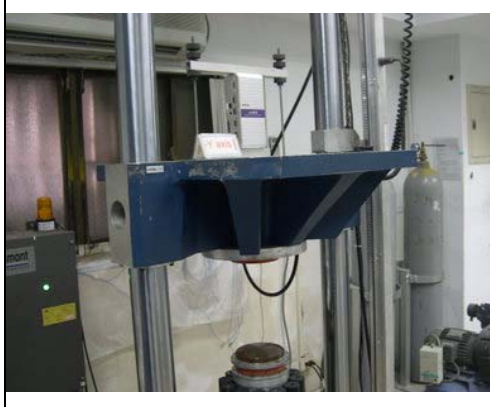
<p>7.Mechanical Shock test: $\pm Y$ axis</p>	<p>8.Mechanical Shock test: +Y axis</p>	<p>9.Mechanical Shock test: -Y axis</p>

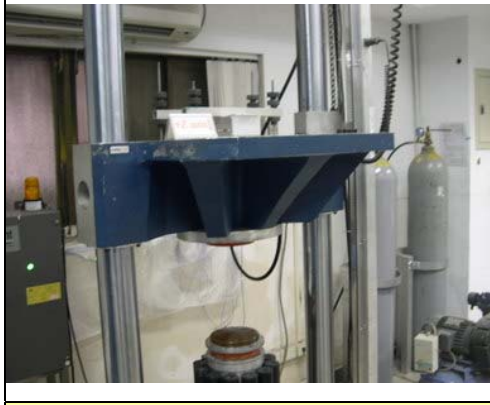
<p>10.Mechanical Shock test: $\pm Z$ axis</p>	<p>11.Mechanical Shock test: +Z axis</p>	<p>12.Mechanical Shock test: -Z axis</p>
