TEST REPORT

Report No.: HC90228/2010

Product Description: JetBox
Style/ Item No.: JetBox 9430/ No.1;
JetBox 3300/ No.1;
JetBox 5430/ No.1;
JetBox 9435/ No.1;
JetBox 5432/ No.1;
JetBox 8150/ No.1
Quantity: Total 6 pieces
Testing Period: Sep. 21, 2010

1. Mechanical Shock test

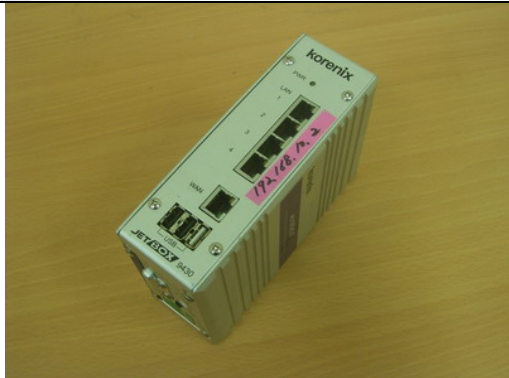
<p>1. Appearance of specimen: JetBox 9430</p>	<p>2. Appearance of specimen: JetBox 3300</p>

Check Item Style/ Item No.	Appearance Check (Visual Check)	Functional Check
JetBox 9430/ No.1	No visible damage	Normal
JetBox 3300/ No.1	No visible damage	Normal
JetBox 5430/ No.1	No visible damage	Normal
JetBox 9435/ No.1	No visible damage	Normal
JetBox 5432/ No.1	No visible damage	Normal
JetBox 8150/ No.1	No visible damage	Normal

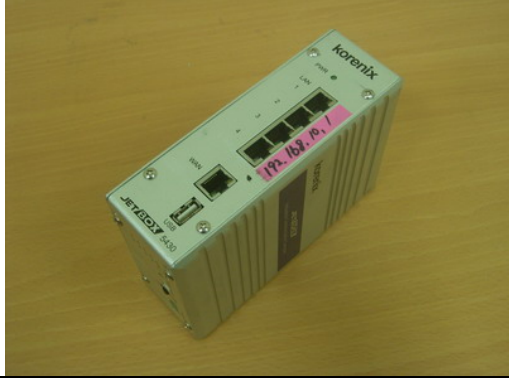
<p>3. Appearance of specimen: JetBox 5430</p>	<p>4. Appearance of specimen: JetBox 9435</p>

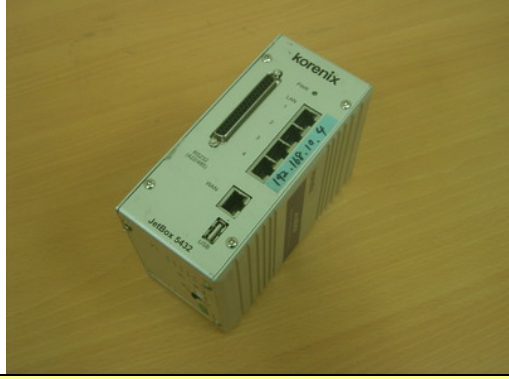
<p>5. Appearance of specimen: JetBox 5432</p>	<p>6. Appearance of specimen: JetBox 8150</p>

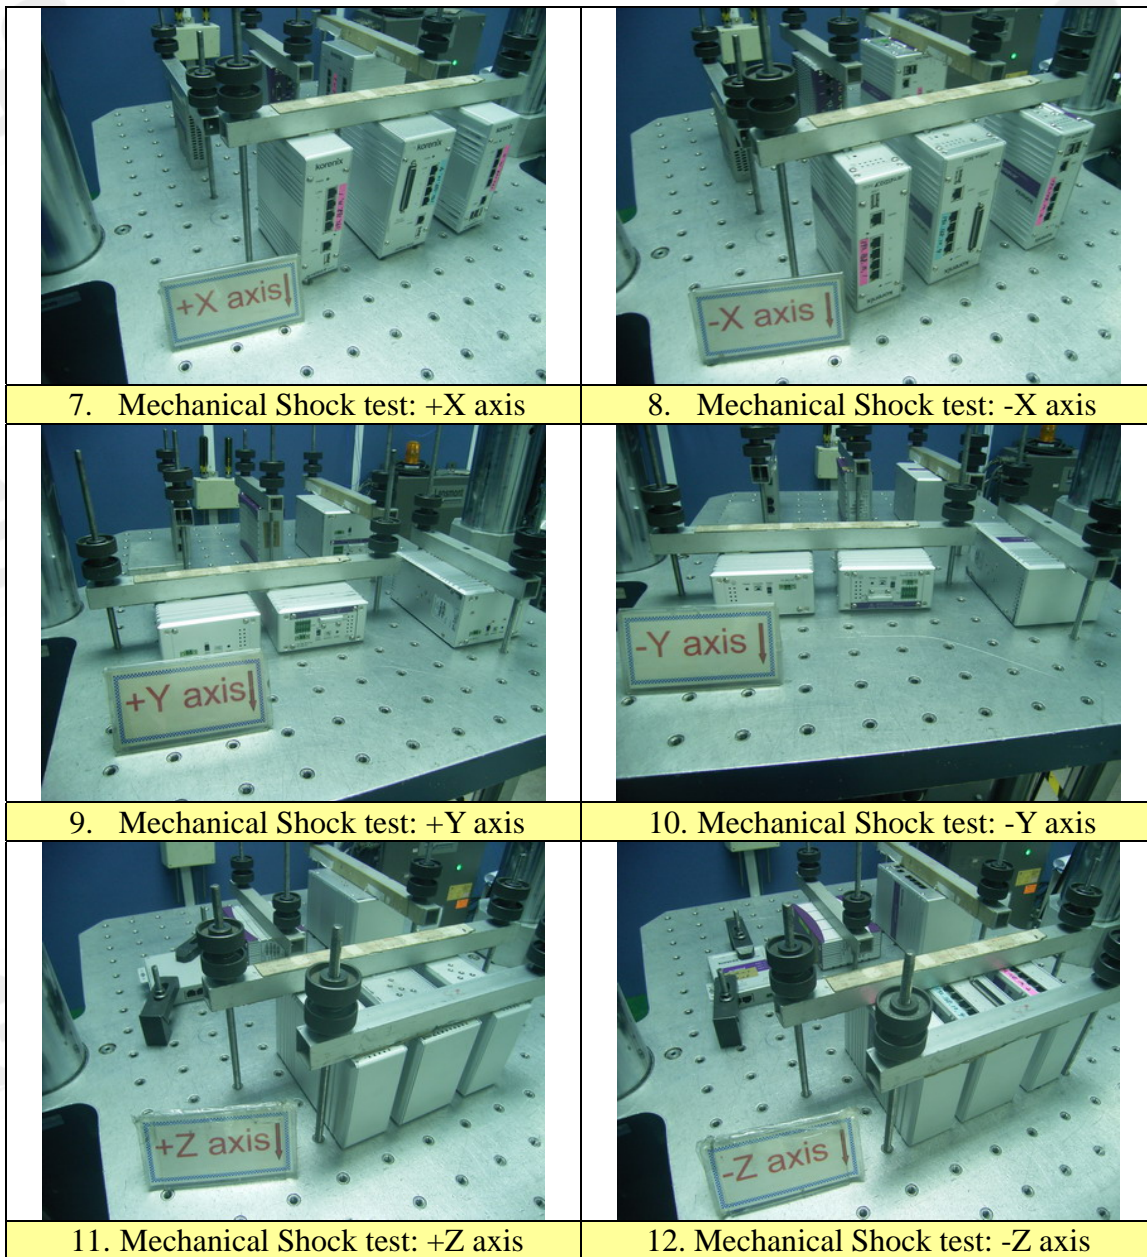
Shock direction: +X, +Y, +Z axes (see photo 7 ~ 12)

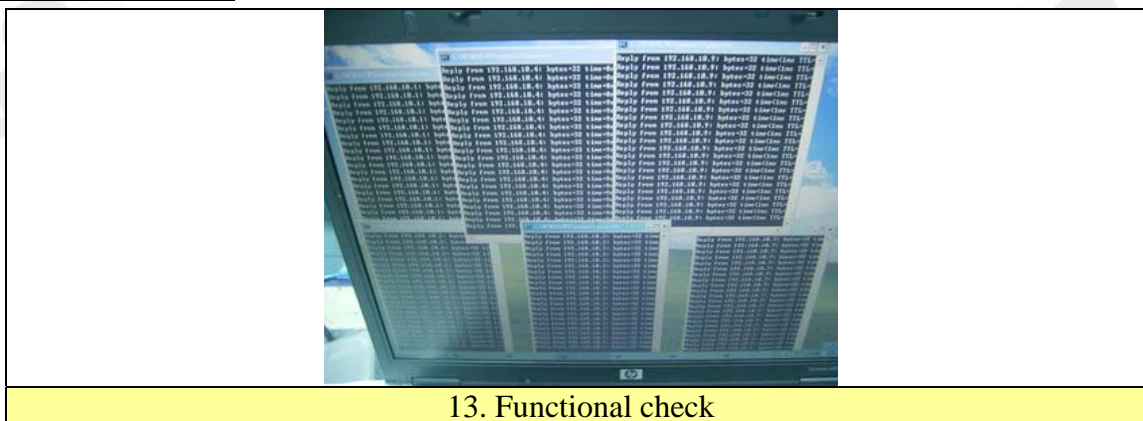
- Examine the appearance of specimen(s) by visual check and perform functional check before and after this test.
- Functional check: Connect the specimen with rated power and Notebook via RJ45 port then examine whether the network communication function of specimen could be work normally or not.

13. Functional check
